**CONTINUING ELIGIBILITY INSPECTION (CEI) REPORT FOR
FLOOD CONTROL WORKS (NON-FEDERAL)**
Honolulu Engineer District
CEPOH-EC-T

1. Project Name: **Moanalua Stream Flood Control Project**
2. Date of Inspection: December 10, 2003 (Wednesday)
2a. Date of Storm: December 7, 2003 (Sunday Night)
2b. Mapunapuna Photos: December 8, 2003 (Monday Morning)

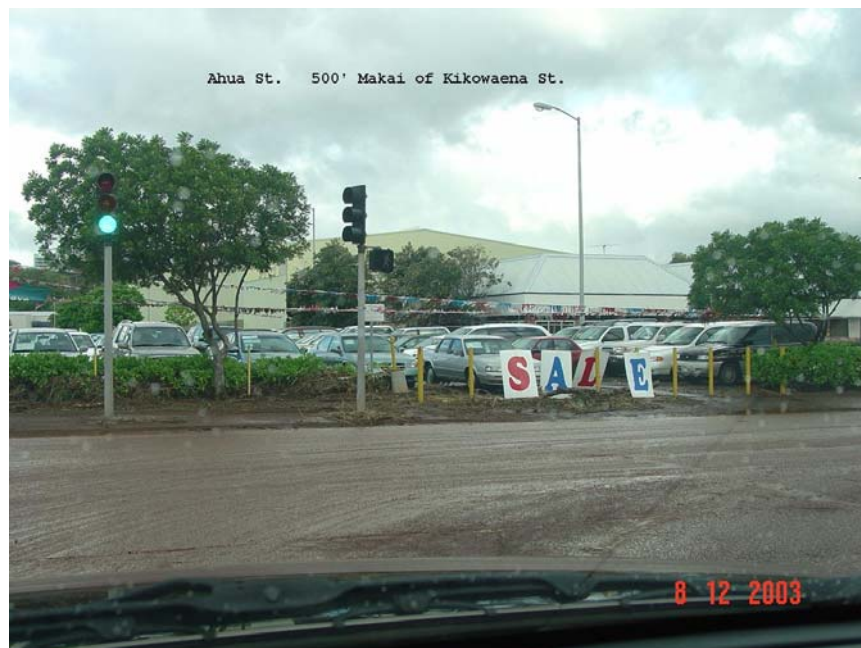
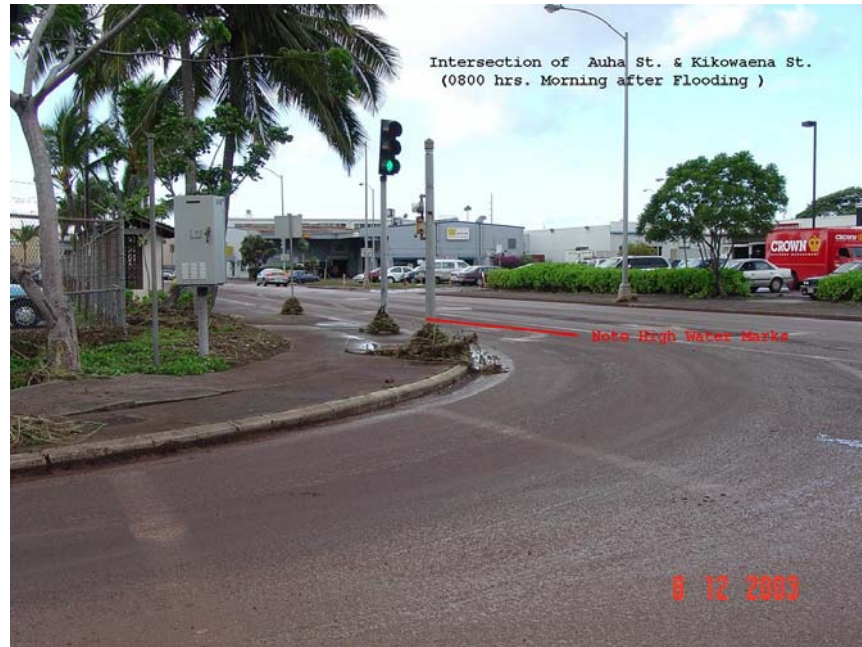
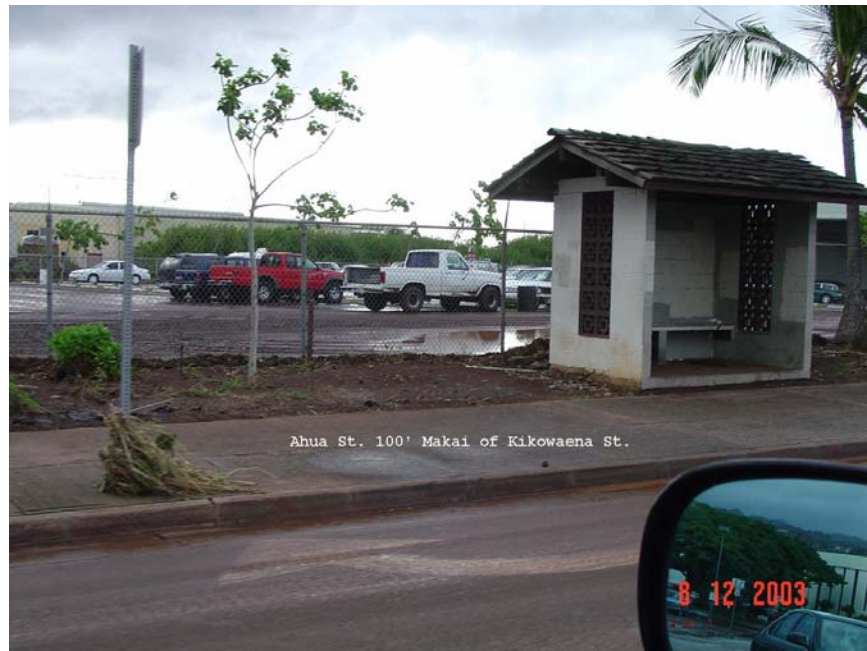
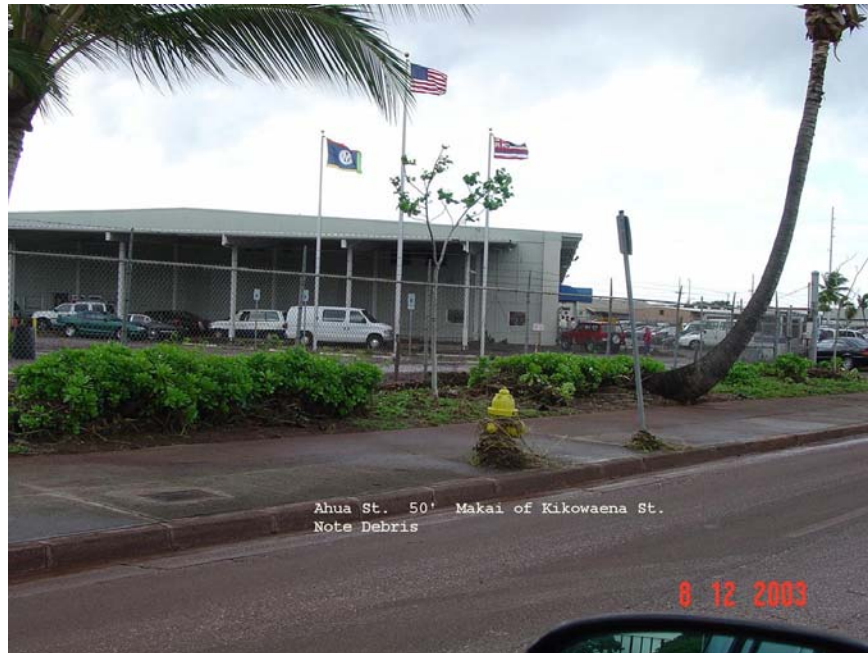
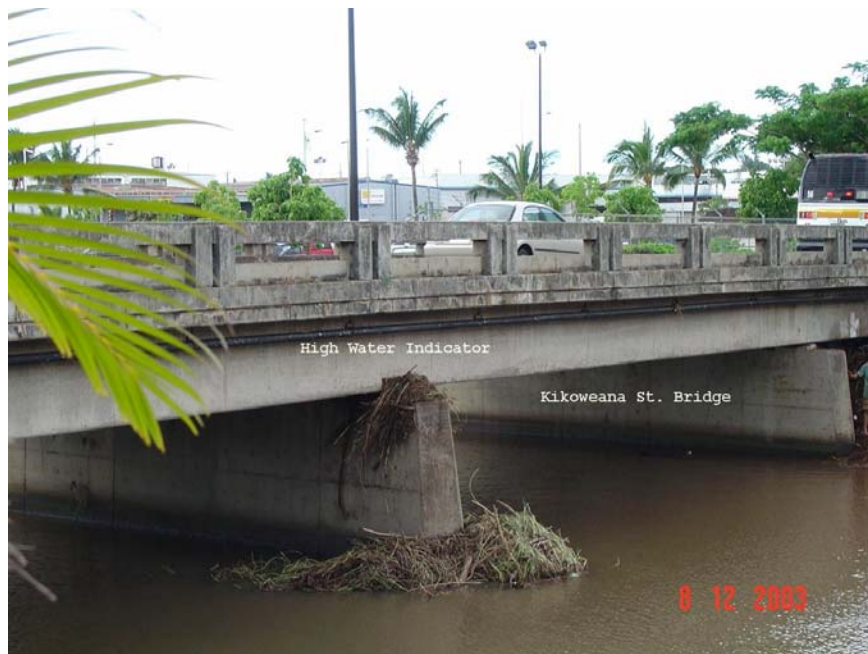
MAPUNAPUNA - PHOTOGRAPHS FROM DECEMBER 8TH 2003 (0800 HRS)

The overall condition of the channel is **POOR**. Worsening of existing conditions on the project occurred only at a few locations. Flooding at the Moanalua Gardens was likely caused by existing stream invert size and flooding at the Mapunapuna Industrial Area was likely caused by debris and vegetation being stuck at the Kikowaena St. Bridge.

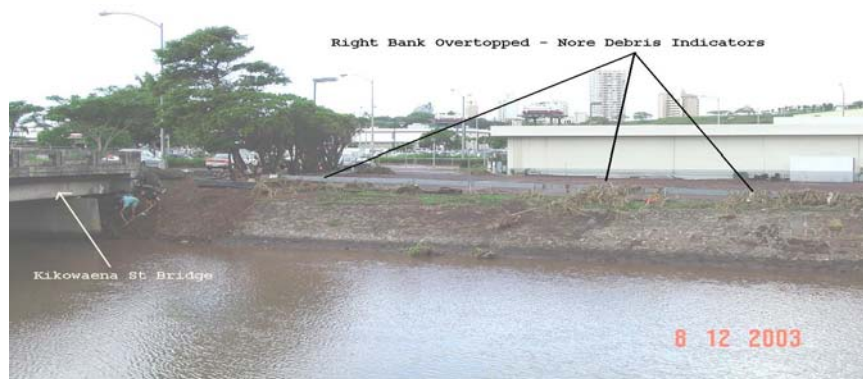
Moanalua Stream, Right Bank, 100' above Kikowaena St. Bridge
